# COMMANDER FLEET ACTIVITIES SASEBO FLEET MOORINGS UNDERWATER INSPECTION REPORT

SEPTEMBER 1983

OCEAN ENGINEERING  
AND CONSTRUCTION PROJECT OFFICE  
CHESAPEAKE DIVISION  
NAVAL FACILITIES ENGINEERING COMMAND  
WASHINGTON, D.C. 20374

FPO-1-83(28)

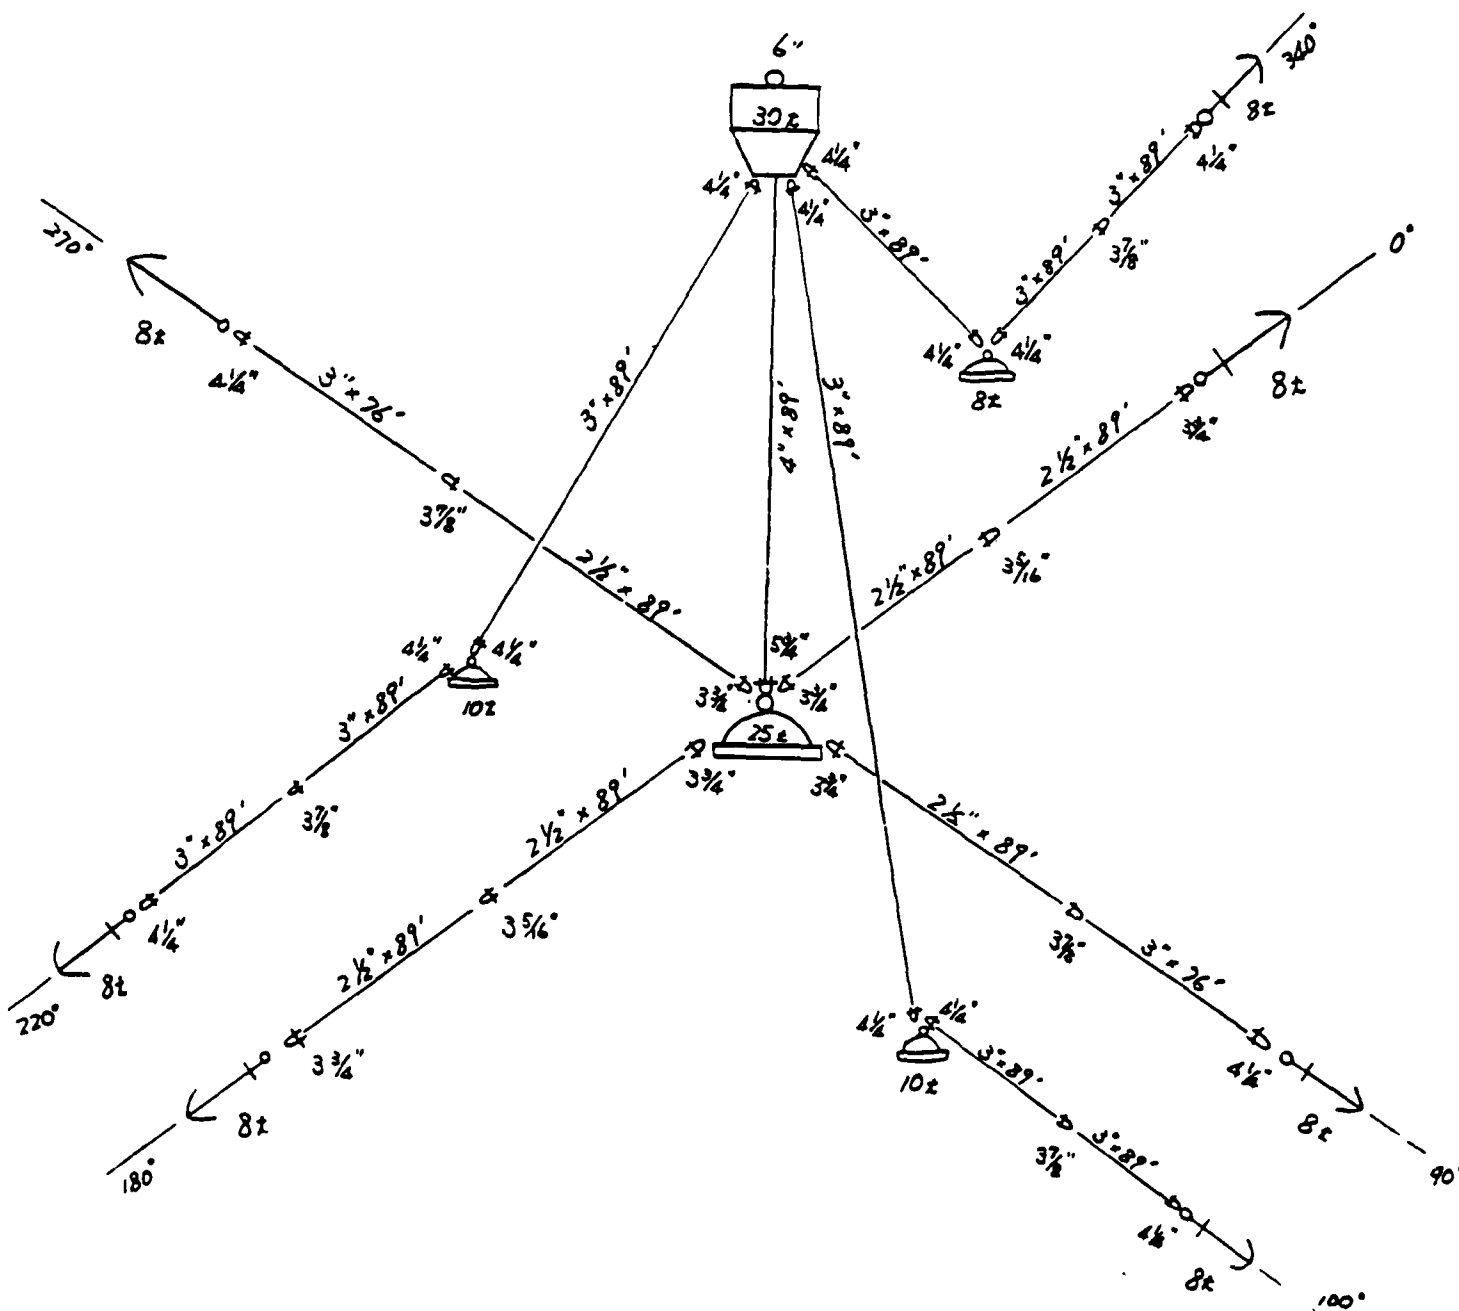
This is a 15-foot-diameter Japanese designed telephone-type buoy with a hawsepipe. The buoy has three legs attached to its padeyes and a riser chain. A 6-foot section of the fender has been sheared off, and the chafing rail is bent and broken. The 6-inch shackle atop the buoy was freshly painted.

The riser is oversized 4-inch chain. Double link measurements taken showed that the chain is worn to between 80 and 90 percent of its original wire diameter. The riser does not have a marine growth covering and enters the bottom at a water depth of 39 feet. The remainder of the riser, the 25-ton sinker, ground legs, and anchors were not visible for inspection.

The three ground legs attached to the buoy padeyes were inspected. Each consisted originally of 3-inch chain. Although most double link measurements were greater than 80 percent, one measurement of leg B, the south-southwest leg, was only 79 percent of its original wire diameter. The legs are covered with a medium covering of marine growth, and each of the legs has scattered areas of extreme rust.

This mooring is in fair condition.

A measurement of less than 80 percent of any mooring component is normally cause for a mooring to be removed from service until an overhaul can be performed. However, in the case of this mooring, the oversized (4-inch) riser is more than capable of handling class A design loads. The worn section of the ground leg does not pose a threat to the safety of the mooring.

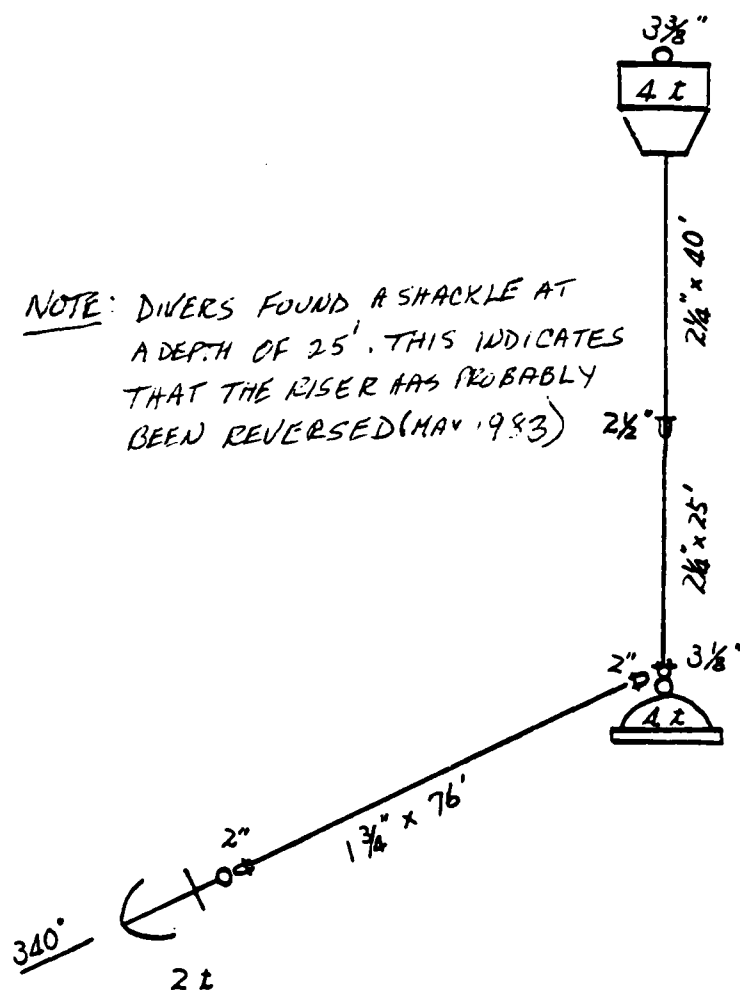
NOTE: DIVERS FOUND A SHACKLE AT  
A DEPTH OF 25'. THIS INDICATES  
THAT THE RISER HAS PROBABLY  
BEEN REVERSED (MAY 1983)

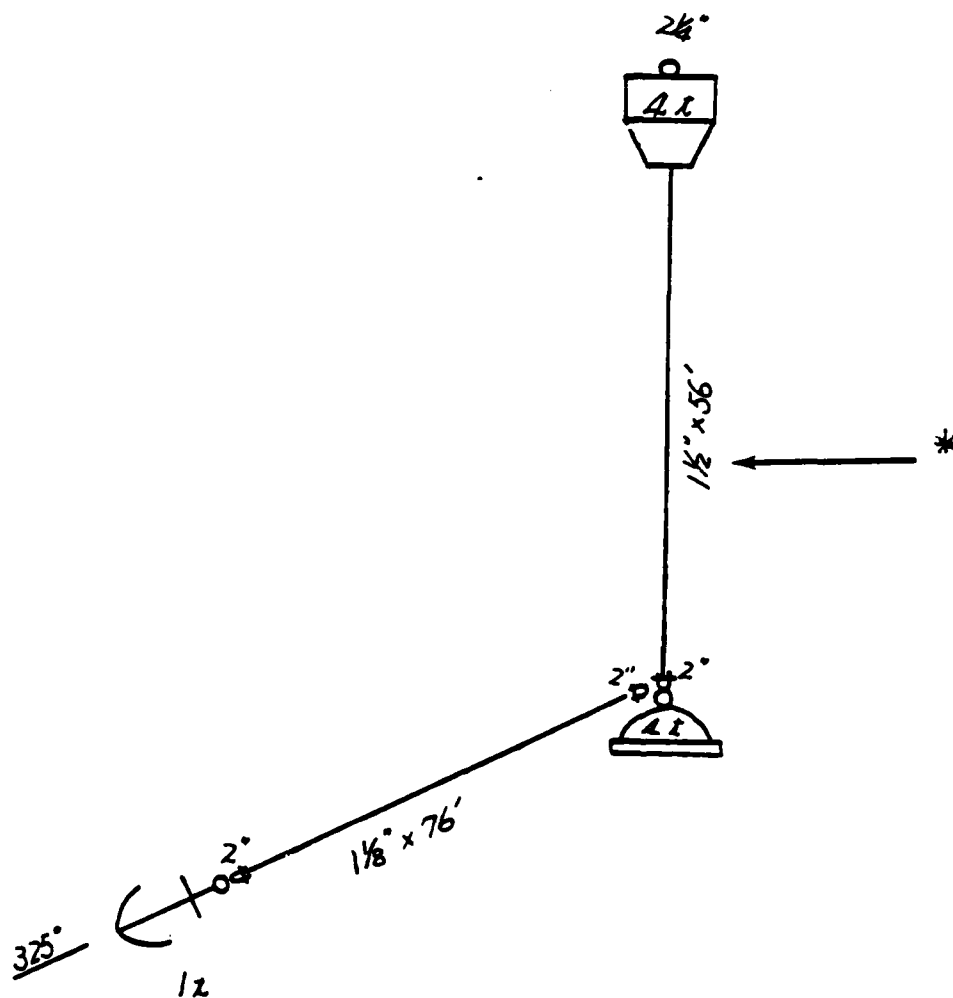
\* DIVERS REPORTED 2 1/8" CHAIN (MAY 83)

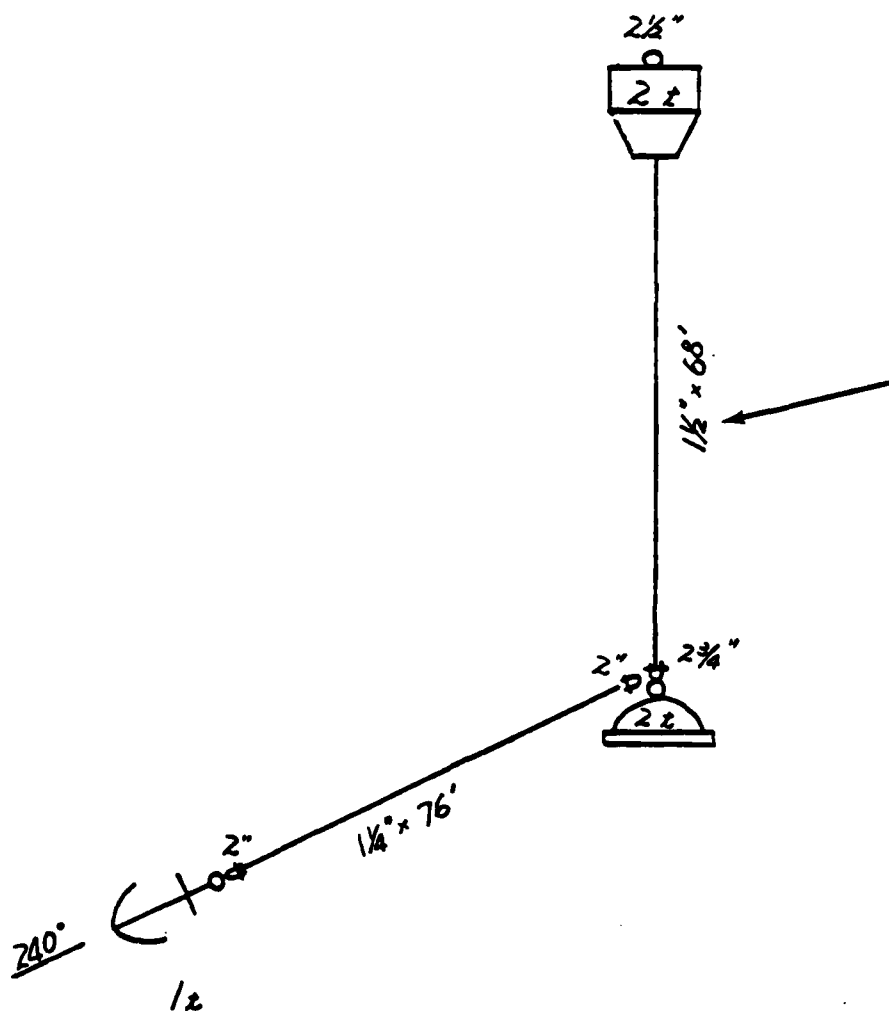
NOTE: DIVERS FOUND 17 1/2'  
RISER CHAIN AND A  
SHACKLE CONNECTION  
AT 32'. (MAY 83)
